Sediments at Mill Dams in the French Creek, Chester County

Prepared by:
Green Valleys Watershed Association For
Pennsylvania Department of Conservation and Natural Resources (PA DCNR)
and Schuylkill Highlands Partnership

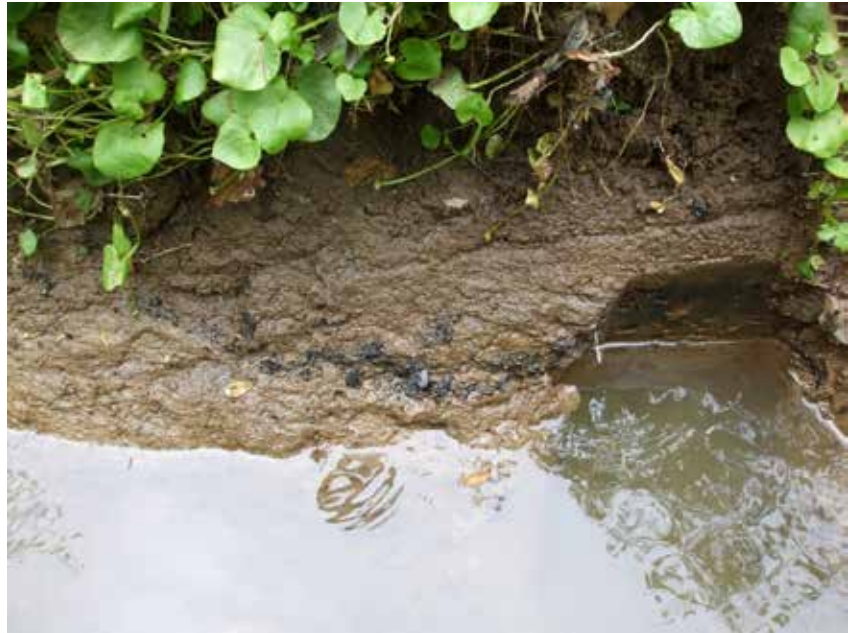
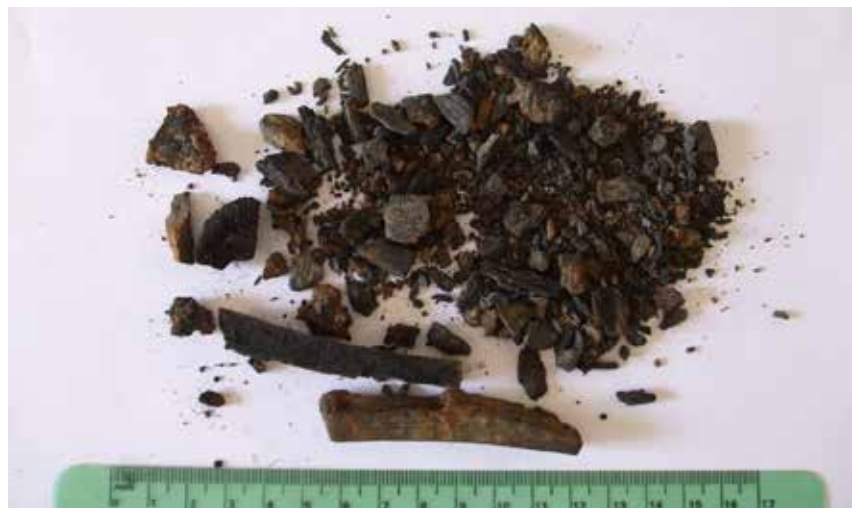
Exposed banks approximately one meter tall of fine grained material are present above the former dam. The bank is nearly vertical in many places, vegetated in others. Three distinct layers are visible above the water. At the base is a layer of grayish material with claylike properties, followed by a thin layer bearing charcoal, and the top layer is about one meter thickness of darker sediments. These layers extend around the terrace. The charcoal layer is consistently just above the grayish layer, and several cm thick in places. The first photo above shows this layer.

*Top: Layer of charcoal above grayish layer of claylike material in the streambank.
Bottom: Charcoal from the streambank layer with sediments washed off.*

charcoal production. A 100 cc sample of the charcoal layer was collected and washed to recover the charcoal which is shown in second photo above.

The source of the charcoal in this layer very likely originates with the extensive charcoal production, transport, storage and use occurring upstream. This would date the sediment above the charcoal to the period after charcoal production began in the area, after about 1717. The bare, vertical banks suggest that bank material is falling into the stream.

Site 15 along the south branch of the French Creek is owned by a land conservation organization. At that site one side of the creek appears to have returned to a more natural state. The creek flows around the terrace with its outer circumference consisting of a rocky bank with no sediments in evidence (see geospatial PDF in appendix C). The inner bank consists of exposed sediments which are eroding away. A possible restoration strategy would be to remove the terrace adjacent to the stream and install rocks and vegetation similar to what is in place on the other bank.

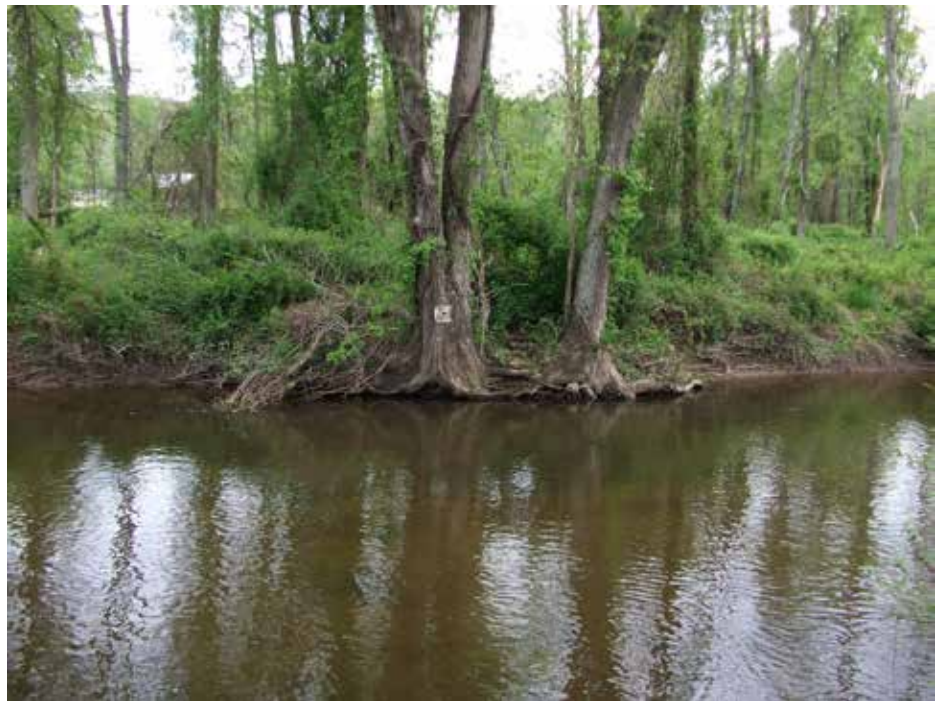
Stranded trees along streambank

examples of large trees with root flares extending out over moving water. These stranded trees are typical of the identified terraces on French Creek.

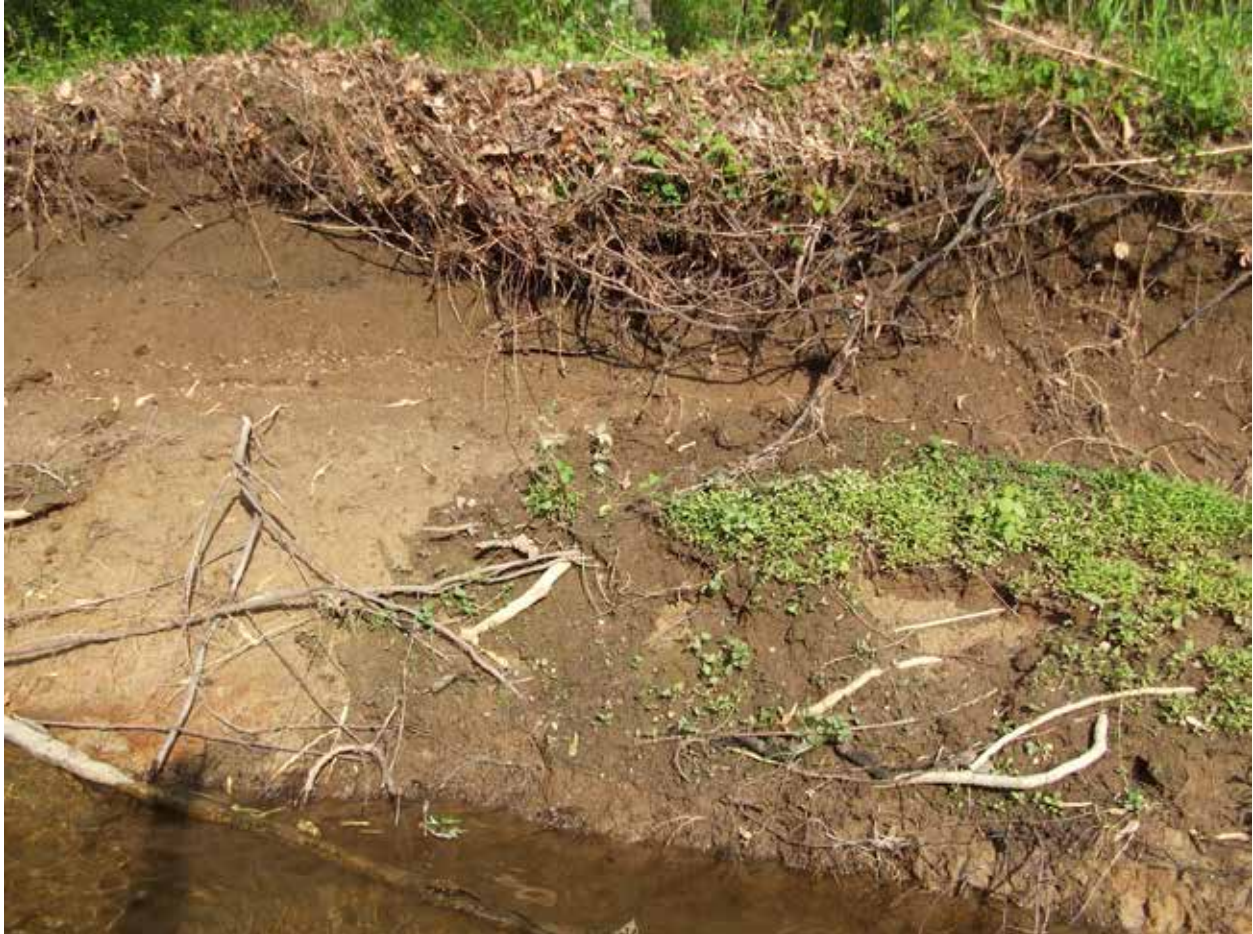
Bank exposures are similar to those at site 15, with a grayish, claylike layer at the base, transitioning to layers of charcoal and brown sediments.

Eroding bank at Site 18 on mainstem showing grayish layer and charcoal

Site 18 at the confluence of the south branch and the main stem of the French Creek exhibited tall banks of sediment which appear to be eroding rapidly. The banks of the creeks there as they appear in the 2008 LIDAR specifically do not agree well with the outlines in the NHD. The south branch currently turns northwest where it enters the main stem and its flow is opposed to the flow in the main stem. The south branch may be undergoing an adjustment at the confluence and this process would release large amounts of sediment. Restoration strategy at this site would be developed after a formal engineering assessment. It should be noted that this site is located within county-owned Warwick Park and that freshwater mussels are present above and below this site.

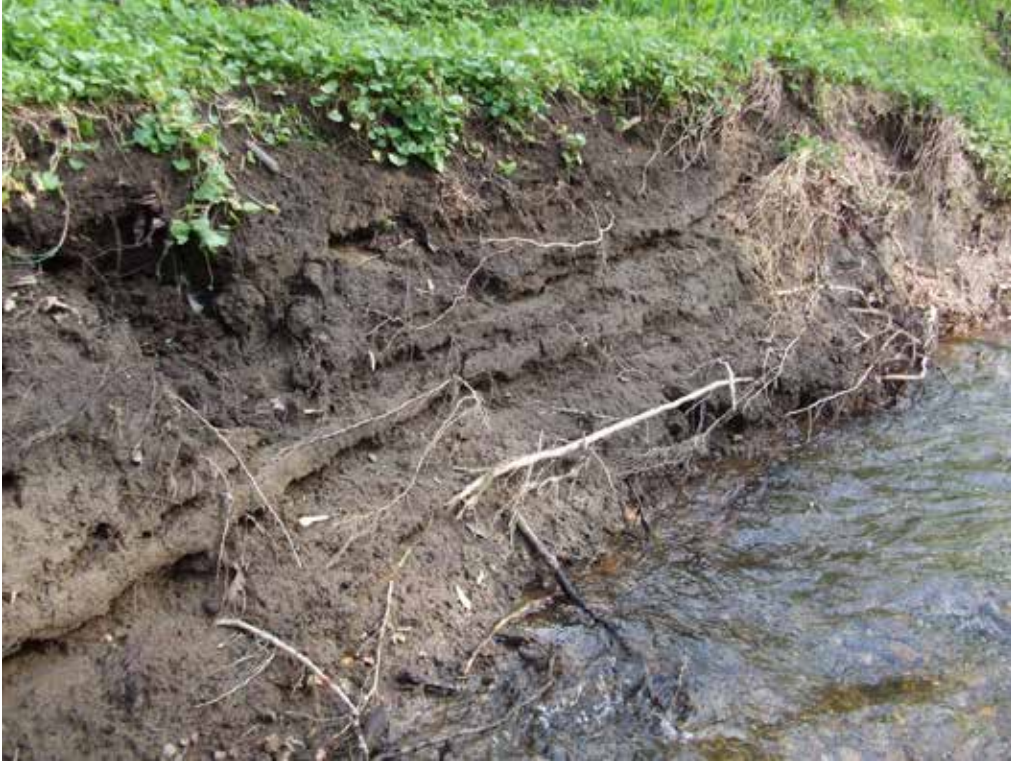
Horizontal layers at site 18

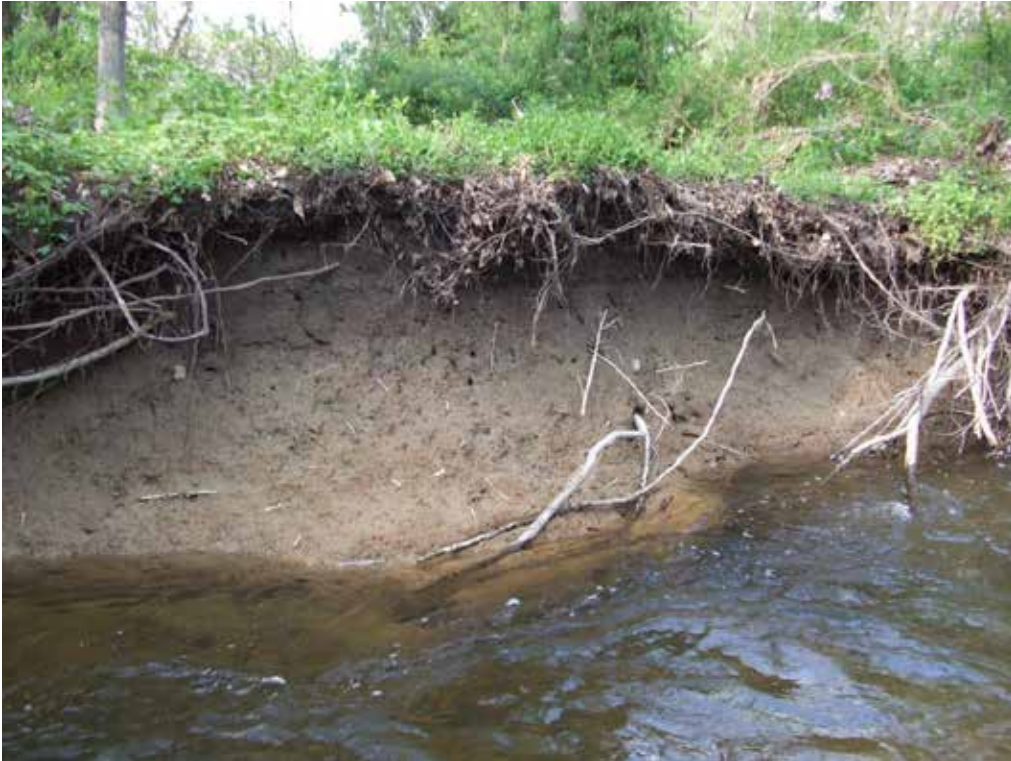
Eroding banks at site 18 on South Branch

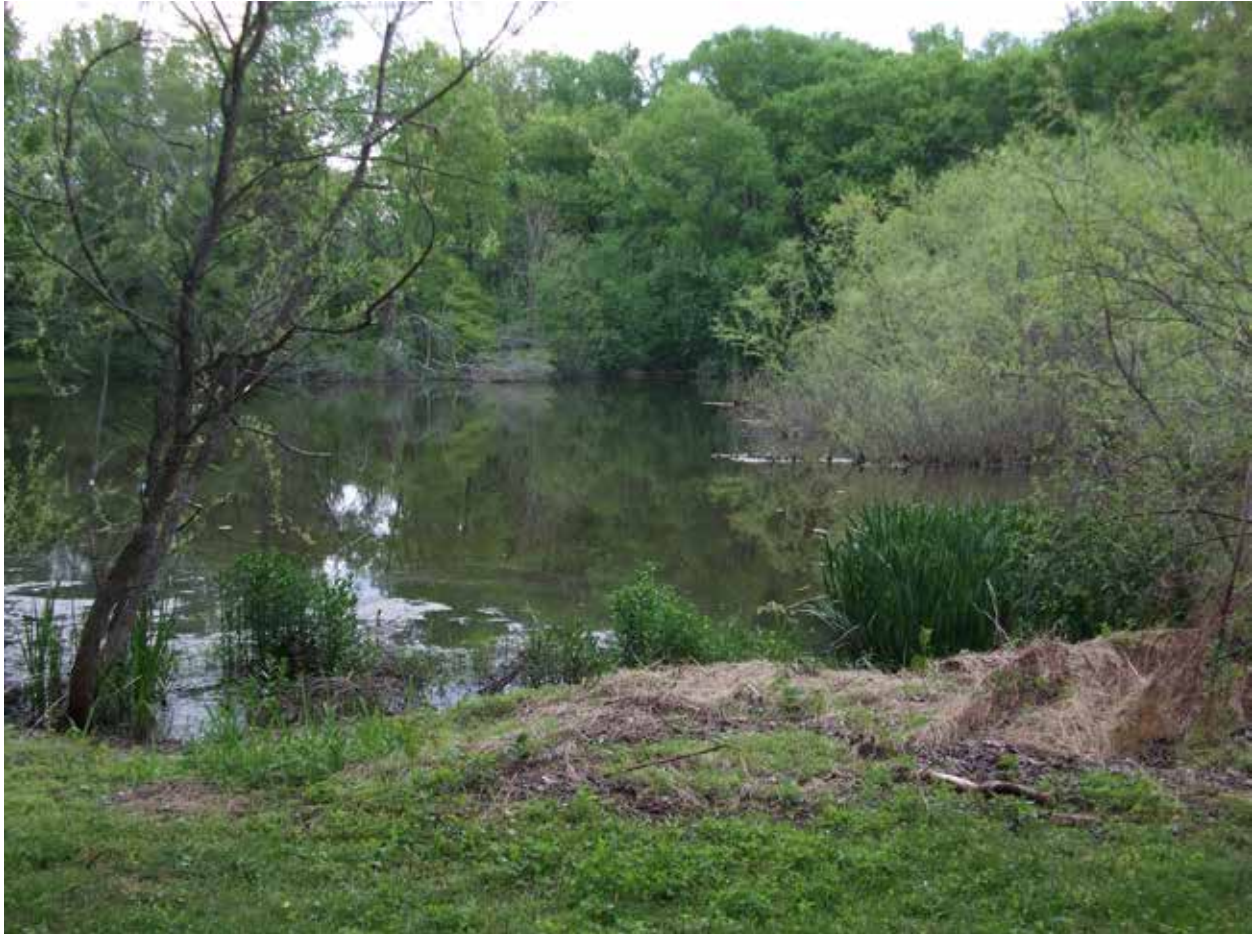
The mill dam at site 16 is in good condition, with a minimal breach of approximately 40 centimeters. Sedimentation is ongoing from E&S failures upstream.

Mill pond at site 16

Site 16 on the Birch Run has a large sediment terrace behind a dam in very early stages of failure. The sediment terrace there is currently functioning as a wetland and supports a variety of wildlife. This site represents a good opportunity to carry out a cost benefit analysis on the merits of maintaining the dam in good condition versus the long term consequences of dam failure and sediment release.

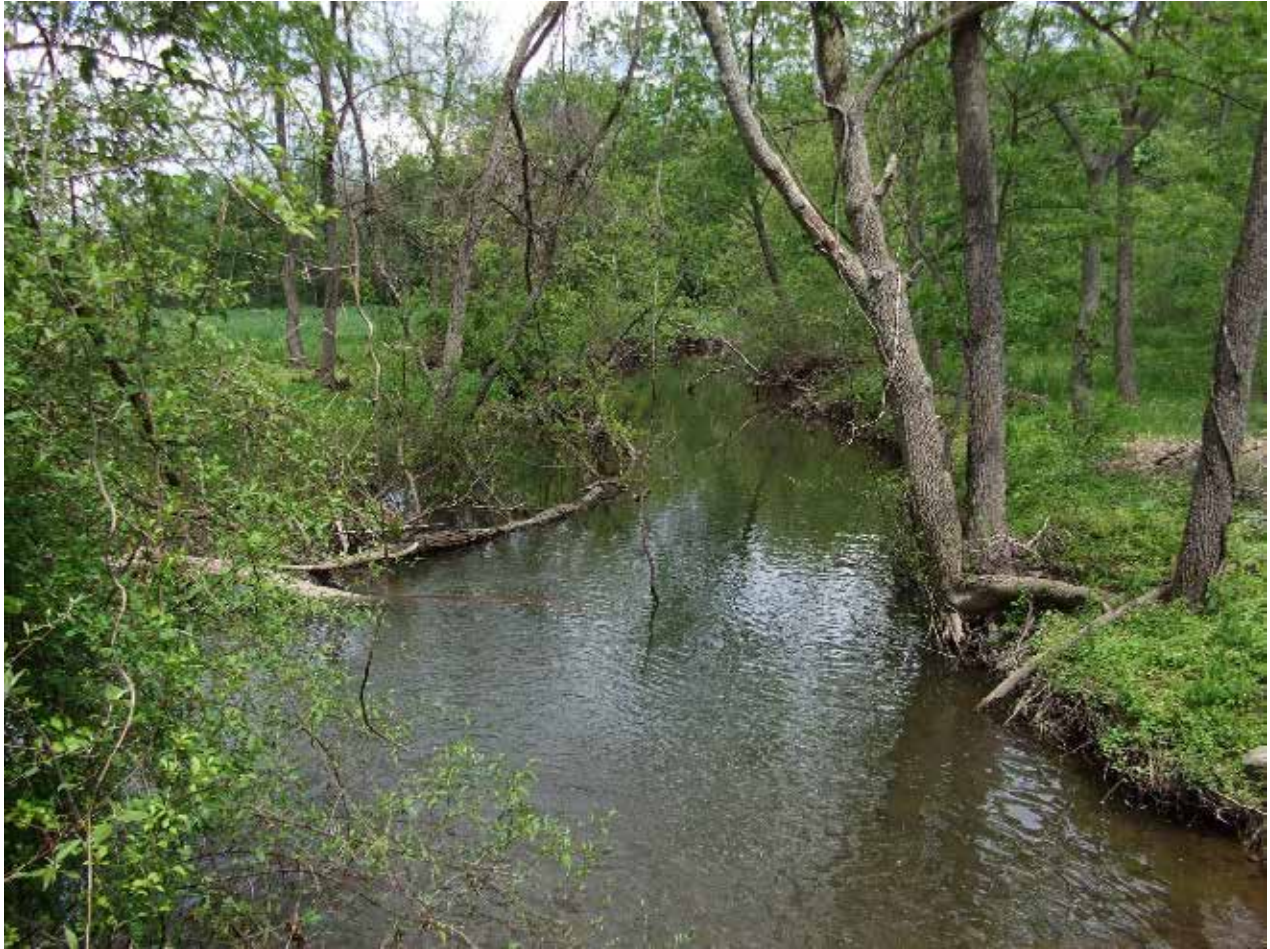
View downstream towards dam.

Site 17 was also used to calibrate the GIS survey. The dam at site 17 is breached by approximately one meter, and the stream has begun the process of incising its way down into the sediment terrace. Bank failure is in evidence, with vegetation and trees stranded over moving water as the legacy sediment is washing away. The riparian buffer planting work is ongoing along the south side of the stream.

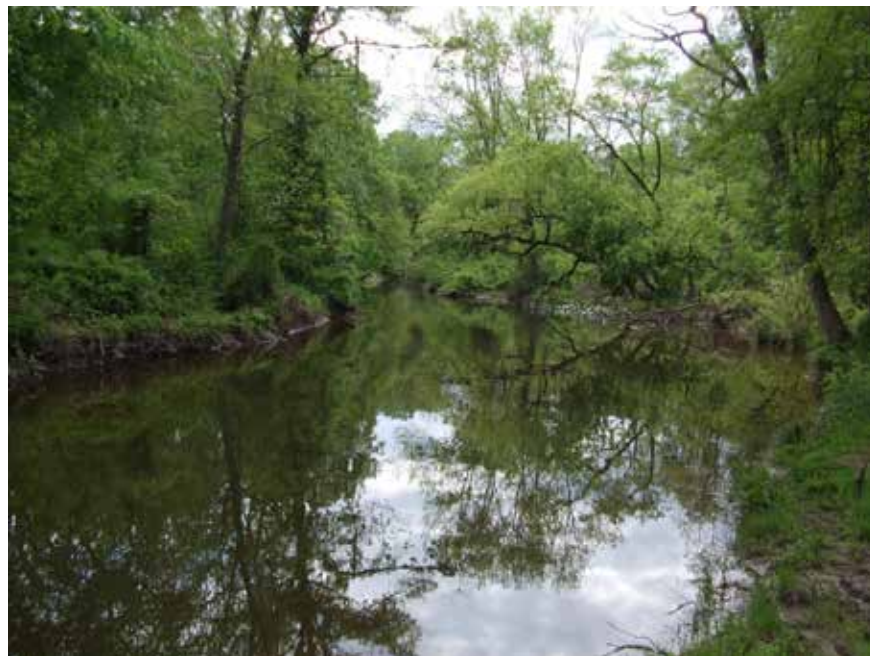
The 1873 Atlas shows the dam at site 9 located above the confluence of the South Branch and the Mainstem, and is probably a continuation of the mill activity described at Site 18. A large candidate terrace is located above the confluence. The mainstem is not deeply incised into the candidate terrace.

Site 9: Looking upstream from location of former dam.

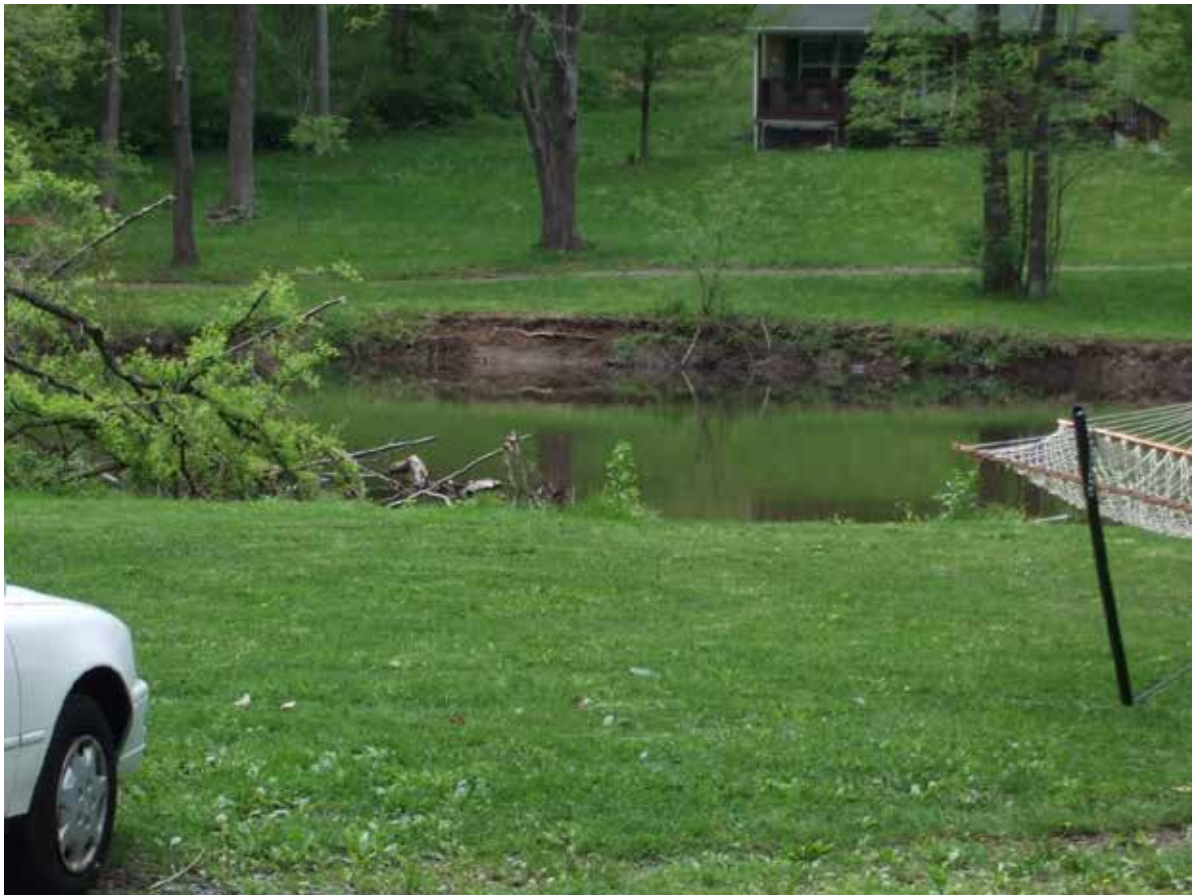
The dam at Site 7 is partially intact and the creek above it is not deeply incised into the candidate terrace. Vertical banks of fine-grained sediment with overhanging vegetation were observed. The substrate consists almost entirely of fine sands and mud.

Beginnings of incisement just above dam.

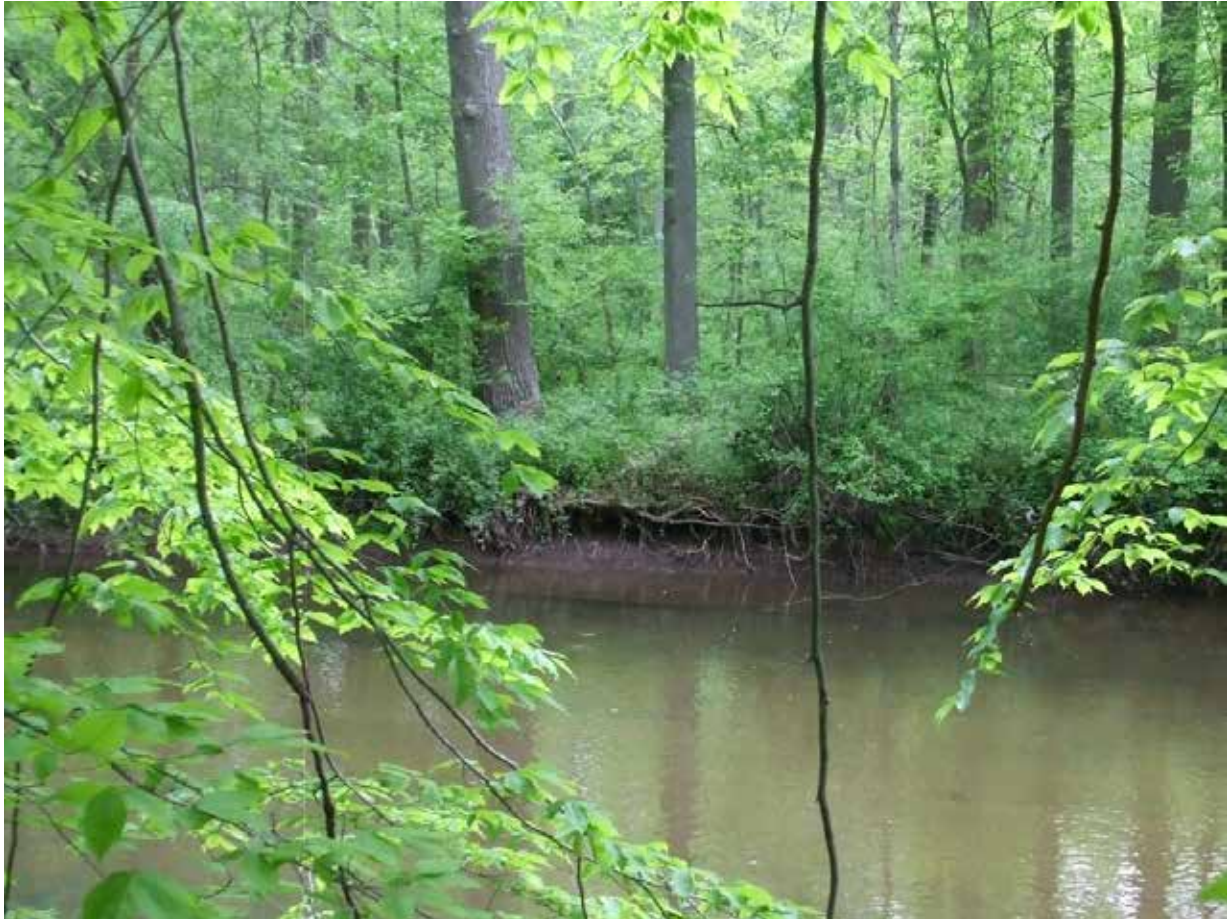
The mill dam at Site 6 is partially intact. Currently the stream is about one meter below the level of the candidate terrace. The banks are near-vertical and un-vegetated, with characteristic stranded trees and vegetation. By most measures this site would be considered to have a high-quality riparian buffer, with mature trees and full canopy closure; yet the bank erosion is ongoing. Substrate at this site also consists almost entirely of fine sands and mud.

Stranded riparian buffer at Site 6

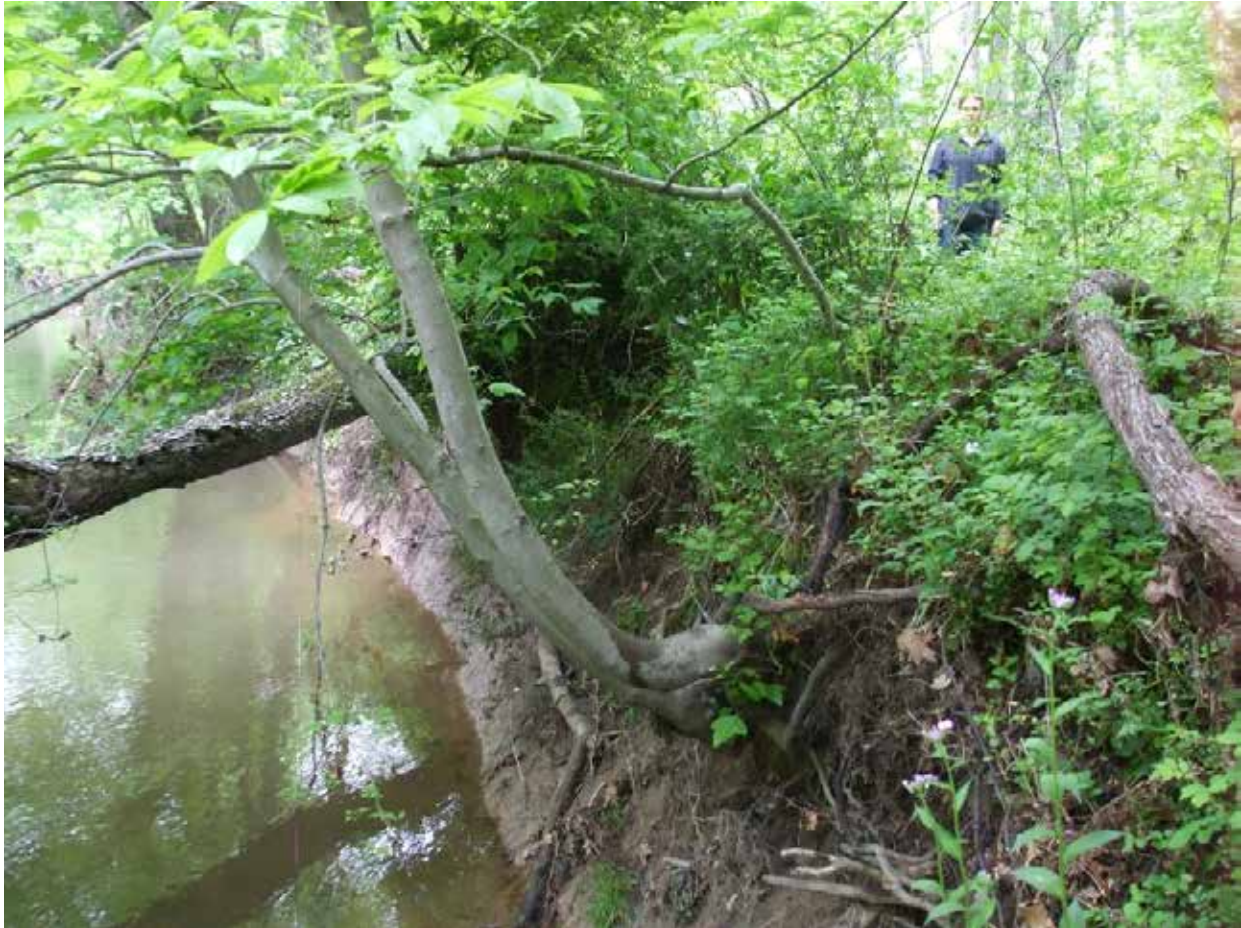
The mill dam at Site 5 is mostly breached. The bank between the candidate terrace and the stream is near-vertical and averaging two meters in height. Vegetation is mainly absent from the banks and large, stranded trees are evident. Substrate consists mainly of fine sands and mud.

Stranded vegetation at Site 5

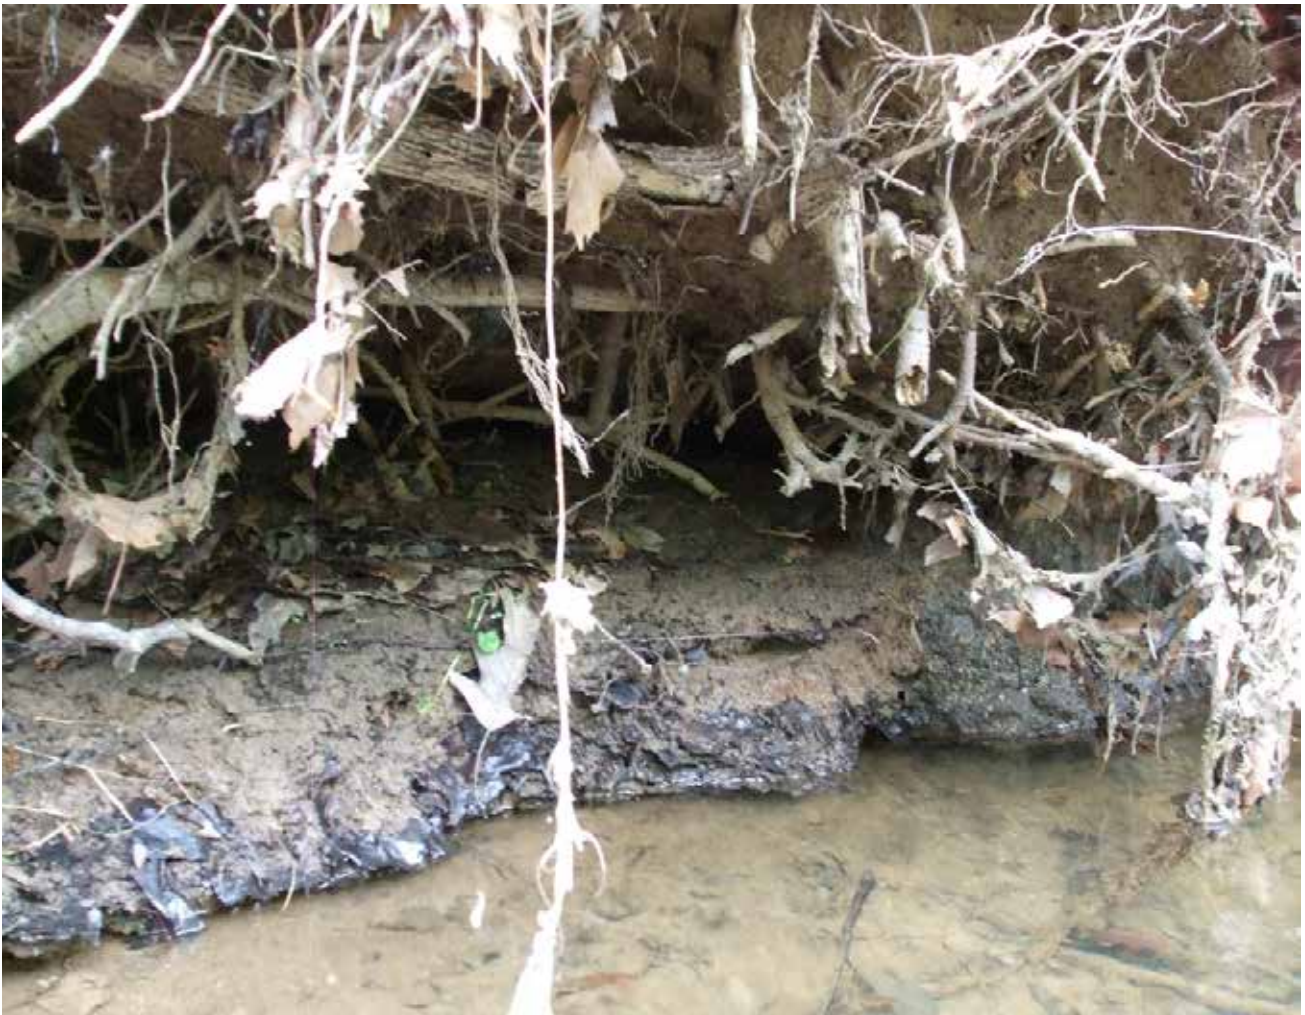
The layers observed consisted of first, a grayish clay layer; second, a compressed layer of leaves and other organic material up to 2 cm thick; and a top layer consisting of darker, silty material. Vertical banks were exposed, un-vegetated, and stranded trees were common.

Leaf layer between underlying grayish clay and overlying darker, fine material.

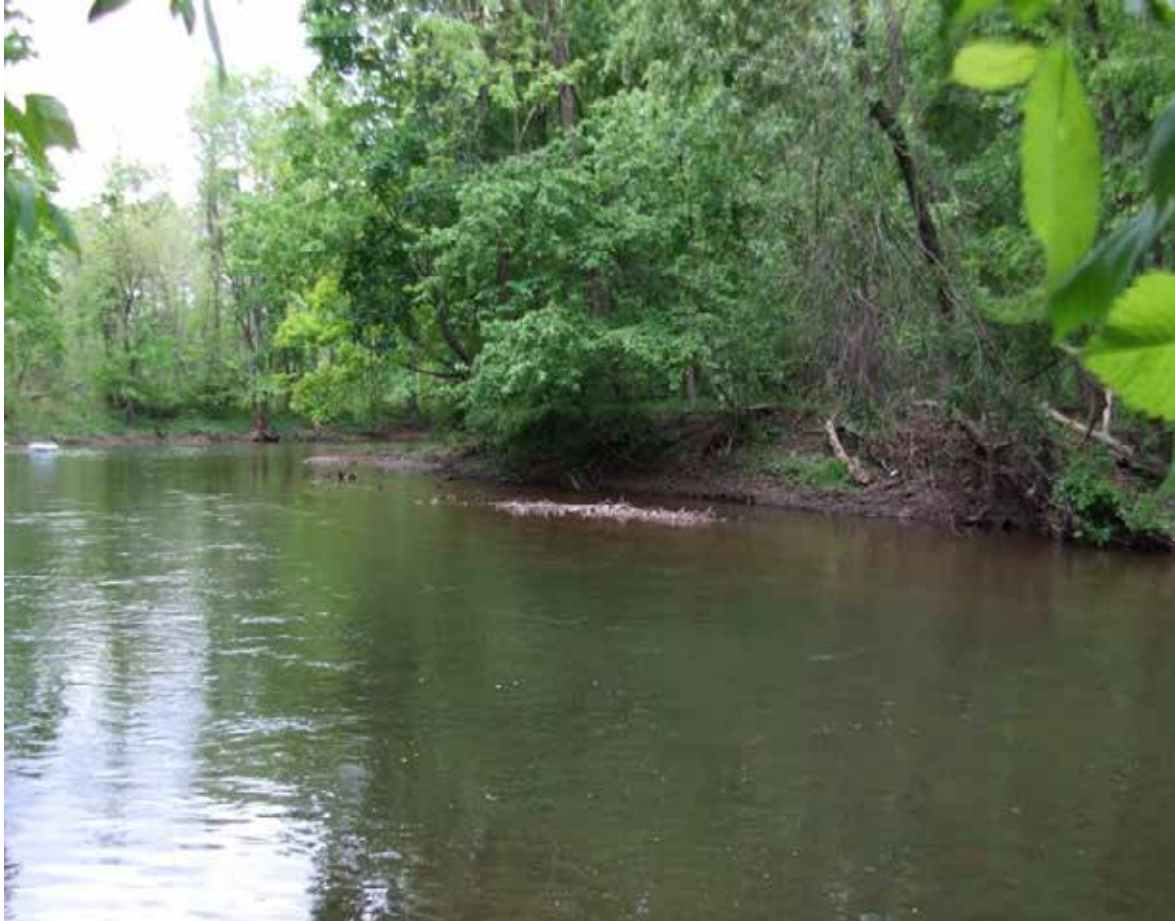
Site 3 is located above the Kennedy Covered bridge. The remains of the dam are visible below the surface of the water. The head race is in good condition. A large candidate terrace is located above the former dam site on the north side of the creek, and may also be present on the south side. Elevations across the terrace vary by less than 1 meter.

Site 3, the French Creek above Kennedy Bridge

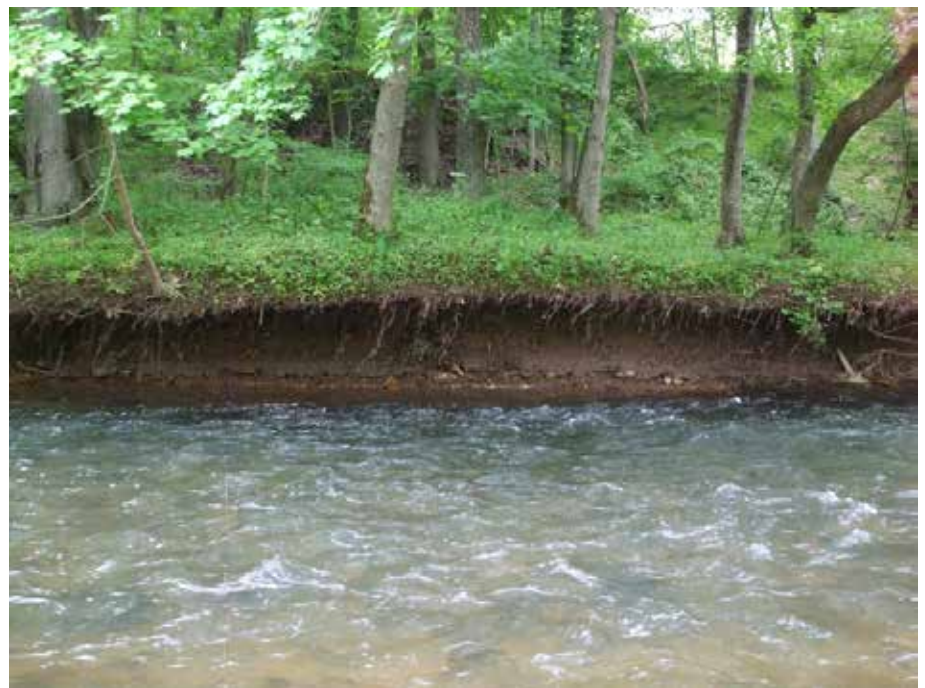
Vertical banks of fine-grained material were consistently observable on both sides of the creek above the dam. Horizontal stratification of the bank soil layers was well-developed. Stranded trees and vegetation indicate that erosion is ongoing.

Terrace above Rapps Dam showing horizontal layers and stranded vegetation.

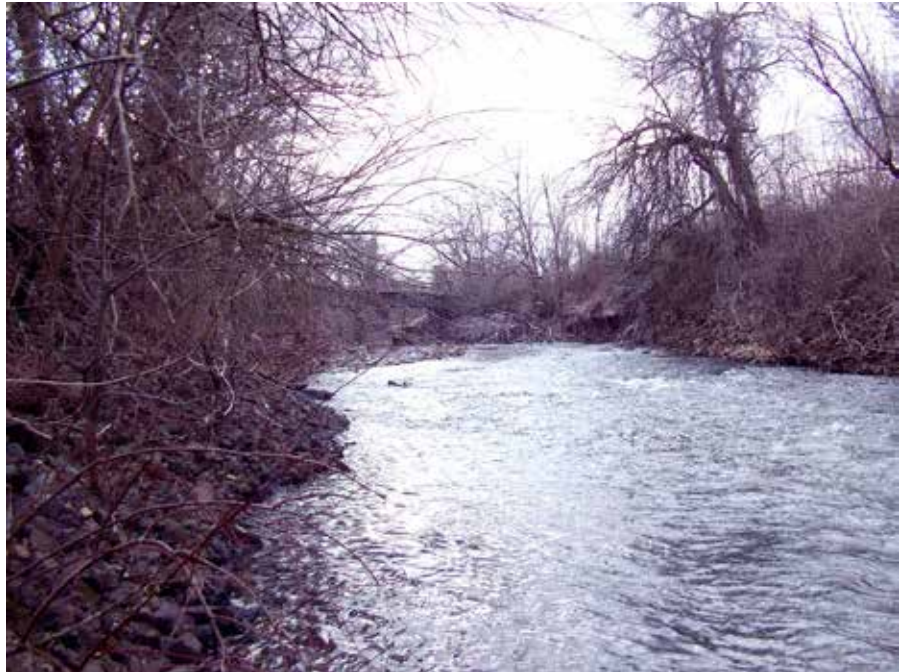
The creek is currently running in a deep channel, and the banks are overlain with centuries' worth of industrial by-products: slag, bricks, iron scrap, etc.

View upstream within terrace, showing steep banks and industrial rubbish.

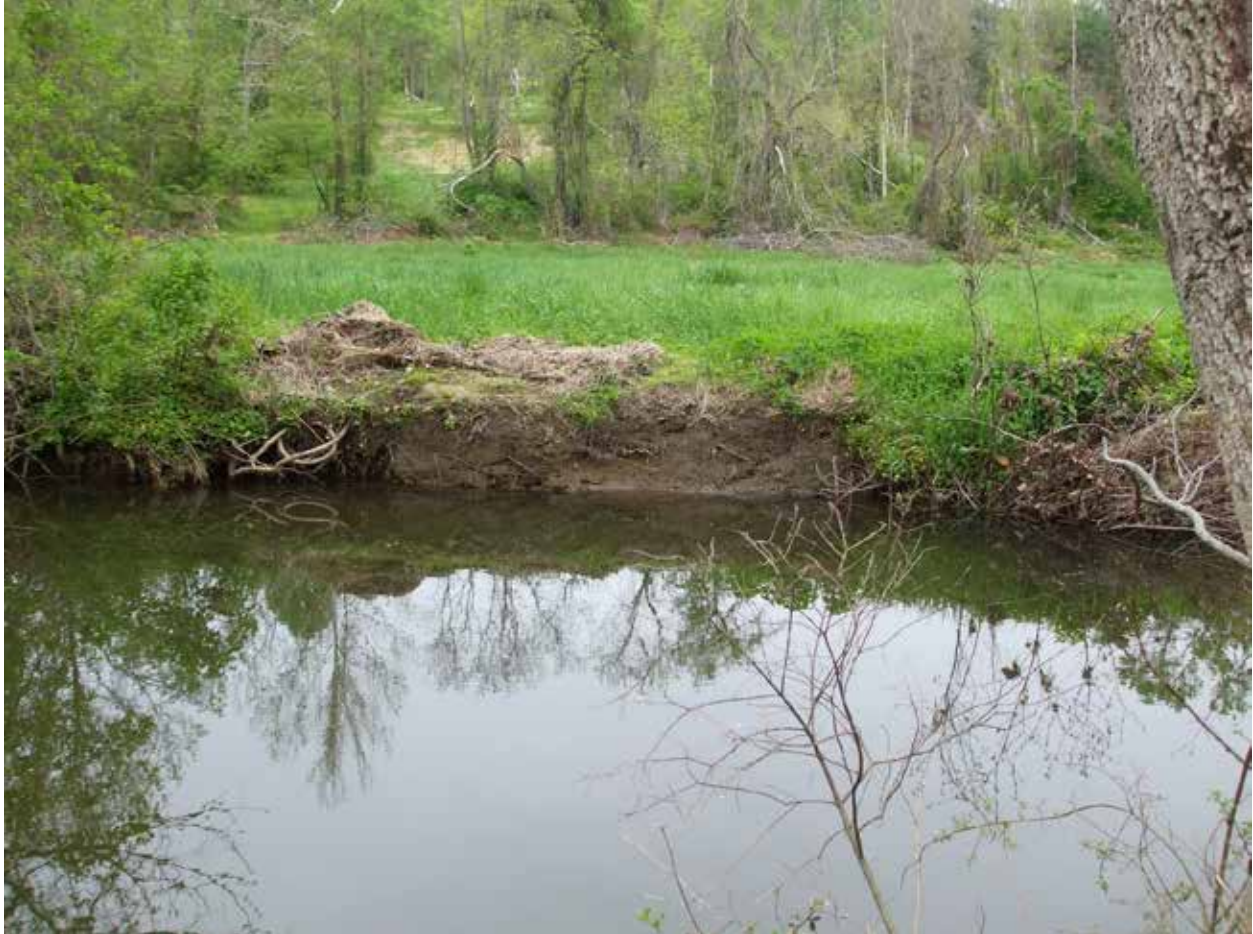
The entire site is in conservation ownership and represents a good opportunity to test alternative restoration strategies. The north bank at this site is currently not receiving any restoration work, and this is where alternative methods could be installed.

North bank of the Birch Run at Site 17

dam. The north bank of the stream presents an excellent opportunity to try out a combination of vegetation stabilization techniques and laying the bank back to a more natural contour.
