Sediments at Mill Dams in the French Creek, Chester County

Prepared by:
Green Valleys Watershed Association For
Pennsylvania Department of Conservation and Natural Resources (PA DCNR)
and Schuylkill Highlands Partnership

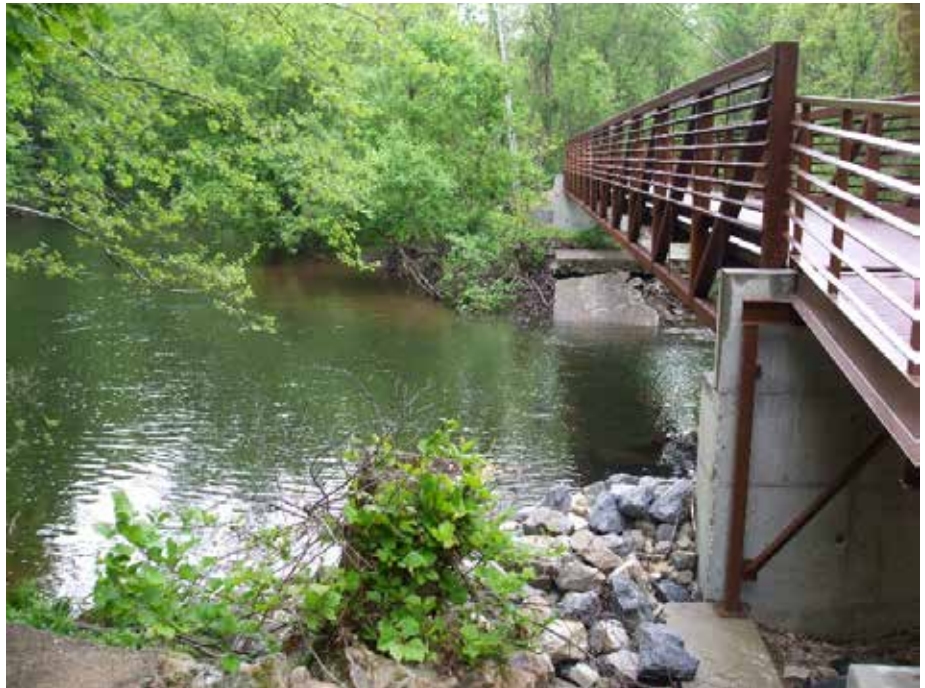
Vertical banks of fine-grained material were consistently observable on both sides of the creek above the dam. Horizontal stratification of the bank soil layers was well-developed. Stranded trees and vegetation indicate that erosion is ongoing.

Estimating erosion rates for this site may be a straightforward process. Historic photos or older topographic maps could allow delineation of the creek as it was in the 1960s. The hurricane in 1972 marks the destruction of the dam and the beginning of stream incision through the sediments.

Pedestrian bridge and trail over Rapps Dam.
